State of Washington Department of Ecology  
Northwest Regional Office

## STORMWATER COMPLIANCE INSPECTION REPORT

<b>Name and Location of Facility Inspected</b> <b>Seattle Iron and Metal Corporation</b> 601 S Myrtle St. Seattle, WA 98108 Facility entrance location: N 47 32' 16.5"; W 122 19' 36.5" (NAD83)	Entry Time 10:00 am	Permit Effective Date 09/20/02
	Exit Time 11:50 am	Permit Expiration Date 09/20/07

**PHOTO ADDENDUM – SEATTLE IRON AND METAL CORPORATION 3/29/06**

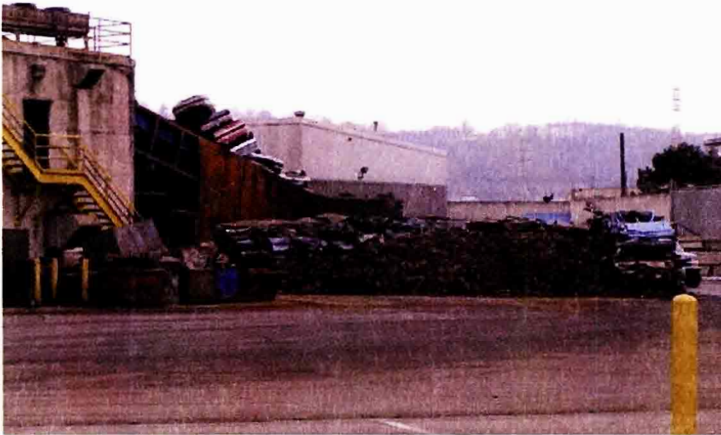
**P3290006 DESCRIPTION: STOCKPILED MATERIAL NEAR SHREDDER**

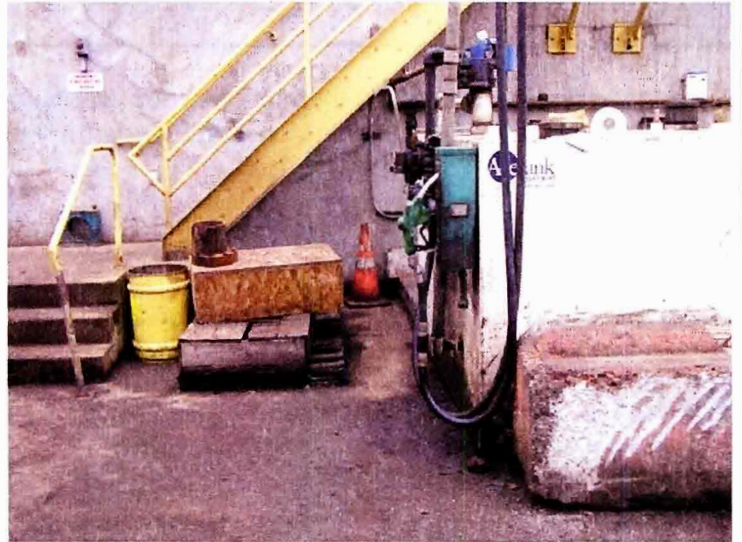
Fueling operations	<input checked="" type="checkbox"/>	Conducted onsite: Yes Type: Stationary There were petroleum stains around the stationary fueling station.
Equipment/Vehicle Maintenance	<input checked="" type="checkbox"/>	Conducted onsite: Yes Repair and maintenance performed outside: No
Treatment System, monitoring point and discharge point	<input checked="" type="checkbox"/>	All stormwater on site is moved through a carefully designed and managed treatment system. The treatment system consists of flocculation and metal precipitation. Stormwater sampling is conducted at a spigot (Photo P3290016) tapped into the treatment plant's effluent pipe. Effluent from the treatment plant is then discharged into the Duwamish Waterway. Sampling is not

**P3290009 DESCRIPTION: DIESEL FUEL STATION**

- The Administrative Order (Order) issued to Seattle Iron and Metal Corporation has not been rescinded. Contact John Drabeck (425) 649-7293 with any questions regarding compliance with the Order and individual permit application process.
- The total zinc value for the second quarter of 2005 has exceeded the benchmark value described in Industrial Stormwater General Permit (permit) condition S4.D.2, therefore consult permit condition S4.C for the appropriate response.
- There were petroleum stains around the stationary fueling station. To prevent petroleum contamination of stormwater, implement the necessary fueling station operational and/or source control Best Management Practices (BMPs).

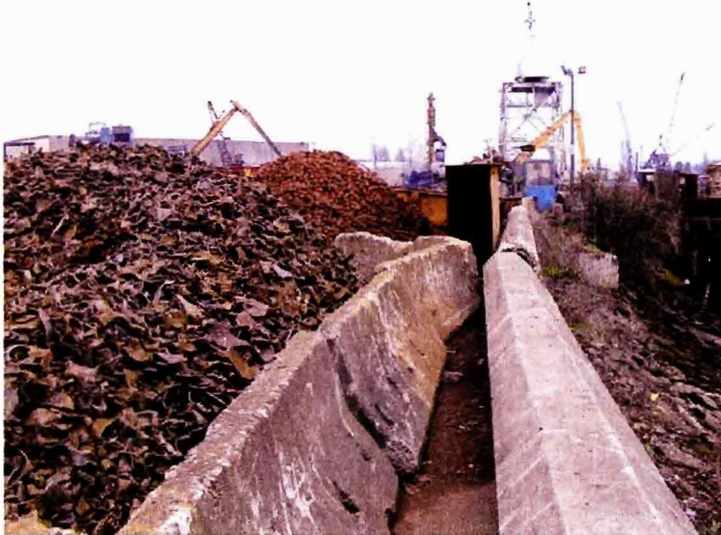
The complaint concerned pictures, that Ecology received on February 17 2006, showing scrap metal from the SIMC site spilling down the bank towards the Duwamish Waterway. Eric Paul, representing SIMC, affirmed that the picture was at his facility and told us that they had cleaned up the area using a giant magnet and installed an additional barrier in the area to prevent future material overflow (photo P3290013).

**P3290013 DESCRIPTION: RECENTLY INSTALLED SECONDARY CONTAINMENT AT SOUTHERN EDGE OF PROPERTY**

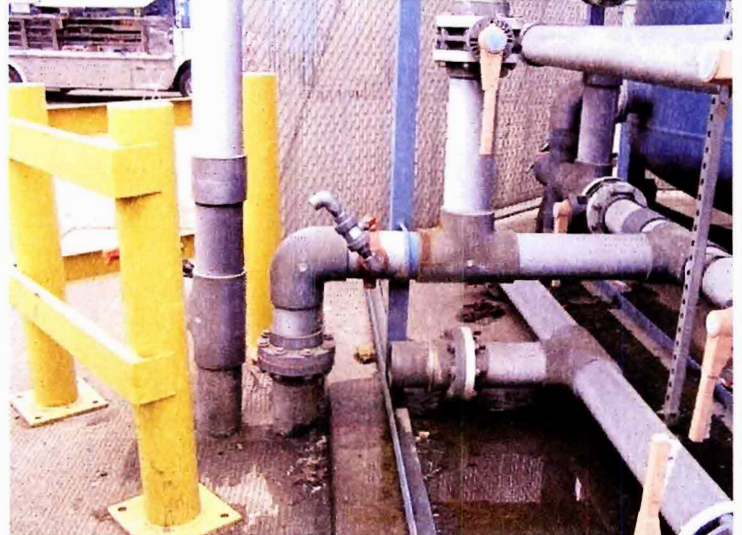
conducted at the Duwamish Waterway outfall because the discharge at this point is a mixture of off site stormwater from Orchard Street and the treated stormwater from the facility.
--	--

**P3290016 DESCRIPTION: SAMPLE POINT- WHERE TREATMENT SYSTEM DISCHARGES TO PIPE THAT EVENTUALLY DISCHARGES TO DUWAMISH.**
